Advanced Energy Monitoring with Wireless Submetering

A Case Study Report Saint-Gobain NorPro Soddy-Daisy, TN

SGNA Sustainability Network Authored by: Rochelle Samuel Patrick Sick

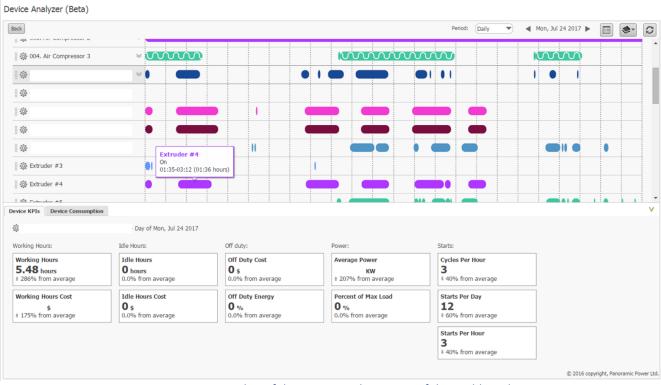
Figure 2. Screenshot of the Device Analyzer Page of the Dashboard

Equipment maintenance is often planned on time intervals (such as monthly, quarterly and annually), which are set based on the estimated operating hours of the equipment, rather than actual run hours. The impact of this assumption can be costly, due to expenses such as unnecessary increased downtime, loss of materials, and discarding the maintenance waste. The **Device Analyzer** tool in Figure 2 shows the actual run time for each piece of equipment being monitored, which allows Soddy-Daisy to extend the maintenance cycle and make maintenance operations more predictive. This reduces the cost of labor, materials, waste, and the related environmental impacts (such as reduced energy consumption and reduced waste). Knowing the actual runtime of each device also allows for better budgeting on a product basis, since there are more accurate estimates of which products use more energy to manufacture. This also opens opportunities to determine and reduce the embodied energy for each product.

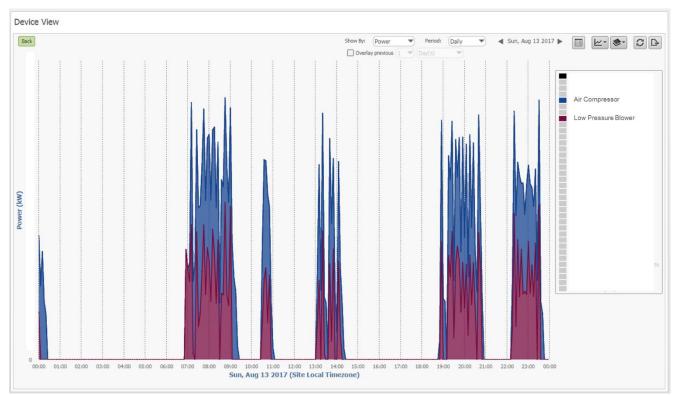
Figure 3. Electricity Consumption Device View of Air Compressor and Low Pressure Blower

A low pressure blower (red) is used to convey material in a seven-minute-cycled batch process. There is a submeter on this blower, as well as on a nearby air compressor (blue). The **Device View** tool shows the electricity consumption in kilowatts, trending daily for these two equipment systems. From the graph, there is a definite positive correlation between the blower and air compressor. The site previously decided to convert fluidization air from the low pressure blower to compressed air so that whenever batching takes place, a second air compressor starts to provide the additional air required for fluidization. Air compressors are much more energy-intensive pieces of equipment as shown in Figure 3. Because of this comparison, the site is now investigating reverting back to just using the low pressure blower for fluidization to save on energy use and charges. For example, on a given day (shown in the Figure 3), the air compressor was left on for over ten hours, which potentially cost the company the equivalent of 4% if their 2017 electrical spend, if left unfixed for a full year.

While investigating the low pressure blower for that project, the team identified that the blower's batch cycle ran for 30 minutes instead of the required seven minutes, because of an equipment issue involving an intermittently stuck valve. The intermittent nature of the problem made it difficult to identify, since the valve worked correctly whenever maintenance was performed. This failure resulted in excessive energy usage due to the previous problem of the low pressure blower and air compressor running concurrently. On the date shown in Figure 3, the low pressure blower ran 13 cycles that lasted for almost five hours more than needed, costing the site an additional 3% of their electrical spend for the year.

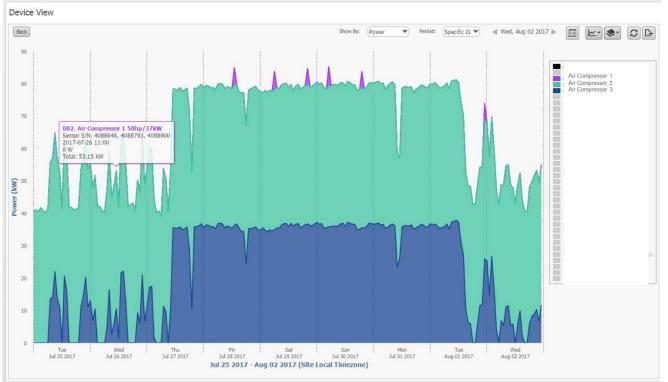
Figure 4. Site Air Compressors Daily Energy Usage Comparison, Device Level View

Figures 4 and 5 showcase the energy usage of the site air compressors from different spatial perspectives. The loads are stacked (combined), showcasing the peak load from the air compressors alone. The different colors

indicate one of the three different compressors onsite. Although all compressors are identical, the **Device View** shows that each of the electrical loads vary. Each air compressor is rated at 50 horsepower and uses 37 kilowatts. Over the week-long period shown in Figure 4, the lead compressor, Air Compressor 1, ran consistently over its power rating at 43 kilowatts on average. Over that period, this issue cost the site an extra 2% of their electrical spend for the year if this problem persisted. In this particular example, operators now use Air Compressor 2 or 3 as the lead, which runs closer to 35 kilowatts, and only include Air Compressor 1 as a backup.

These differences indicate an equipment issue, which quickly becomes a plant reliability issue. Without the dashboard, the inefficient compressor would have continued to run, possibly resulting in premature failure. The site would have gone through unwanted downtime to do maintenance, and cost extra resources such as labor, production capacity, and energy losses.

As a result of this determination, Soddy-Daisy chooses which air compressor to act as lead compressor on a periodic basis based on its performance and energy efficiency. Being able to know when equipment will fail and when to take action is a major maintenance win for Soddy-Daisy. An operator looking at the machines is just able to tell that they are running, not the electrical load; this level of granularity is only possible by seeing the consumption data visually.

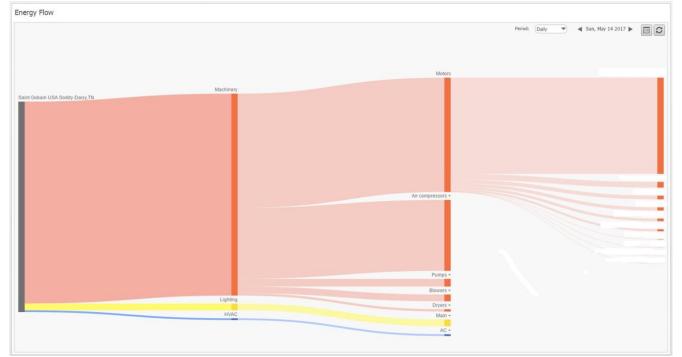
Appendix D-3. Sankey Diagram

This Sankey diagram parses out where in the plant the incoming electricity is consumed. This is another way to visualize which devices, or equipment, are consuming the most energy. Note: Electrical load names have been omitted

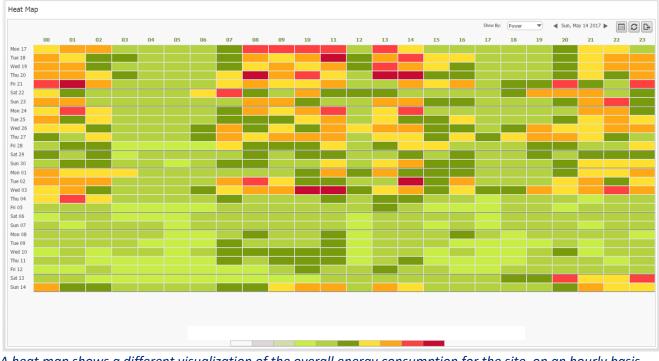
A heat map shows a different visualization of the overall energy consumption for the site, on an hourly basis. The range of colors demonstrate the intensity of energy use in one hour in relation to the other hours. Those hours highlighted in red signify a high energy usage in that period. Pinpointing when these peak usages occur can help determine what is causing them.
